Observation and analysis of coastal changes in the West Estonian Archipelago caused by storm Ulli (Emil) in January 2012

Hannes Tõnisson†, Ülo Suursaar‡, Reimo Riviš†, Are Kont† and Kaarel Orviku†

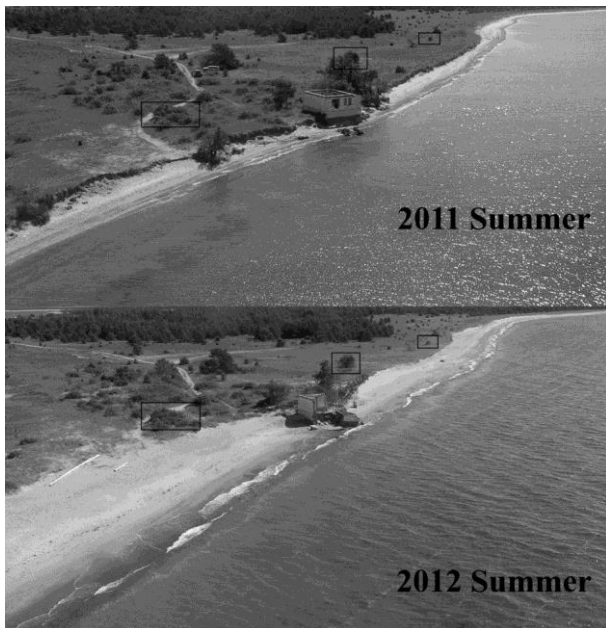
Figure 3. View to the lighthouse keeper's house at Cape Kiipsaare before and after extreme storms in winter 2011/2012.

The largest changes on Cape Kiipsaare were measured south of the former lighthouse keeper's house, which today is located directly on the beach (Figure 3). Southerly and south-westerly winds and waves predominated for the duration of Ulli. The recession of the sandy scarp north of the old house reached only 3 m during Ulli, whereas it reached 6 m during Berit. Most of that erosion took place at an elevation of nearly 2 m and therefore the height of the scarp was mostly below 0.5 m.

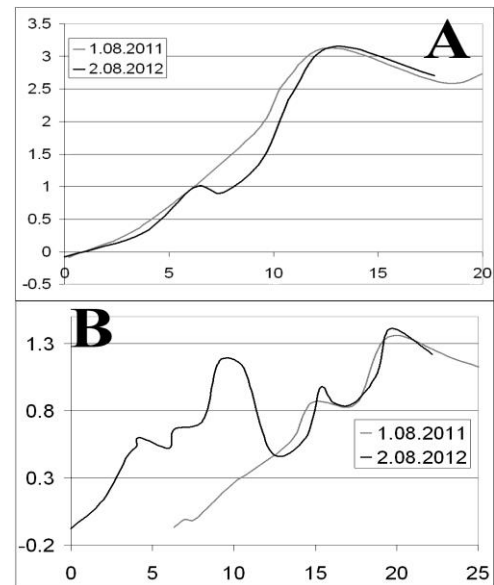
Figure 4. Levelling survey reveals that the sections more exposed to the storm waves (A – proximal part of Küdema Spit) experienced significant erosion from the elevation 1.0 to 2.5 m while notable accumulation appeared on the distal parts located more or less protected from the direct wave impact (B – distal part of the Küdema Spit). Both axes units in metres.

The changes registered at the Küdema study site were very similar to the ones measured in Kelba (Figure 4). At the elevation of 1-3 m, a 0.5-1m thick layer of sediments was eroded from the proximal part of the spit, which was well exposed to the storm waves. Intensive accumulation (5-10 m³ of fresh sediment per one meter of shoreline) was registered on the distal part of the spit and on the sections less exposed to the dominating direction of the storm waves. Cape Sõrve, which is relatively well exposed to both westerly and easterly wave directions, showed surprising results. There were no significant changes despite very strong storms accompanied by very high sea-level. The only notable changes were marginal erosion on the eastern side of the cape, nearly 0.5 km from its tip, and marginal accumulation (a new layer about 0.4 m thick) at the distal section of the eastern side of the cape.
