4 The Baltic States

Estonia, Latvia and Lithuania

Hannes Tõnisson, Kaarel Orviku, Jānis Lapinskis, Saulius Gulbinskas
and Rimas Žaromskis

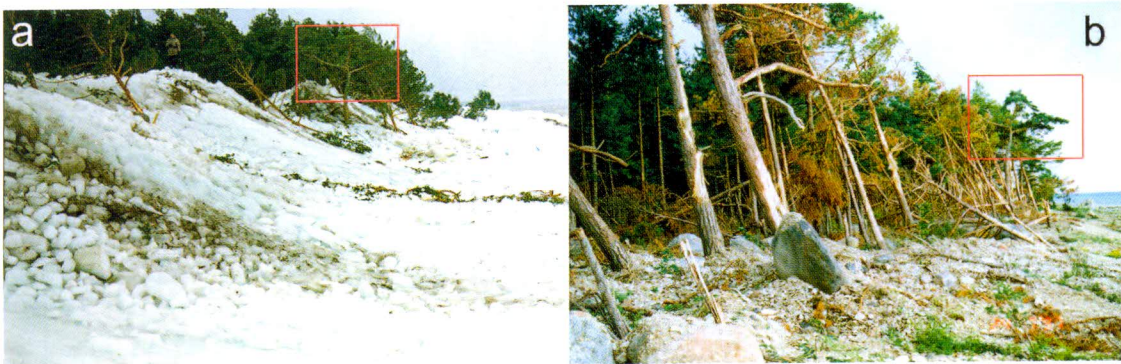
■ **Figure 4.1** Sea ice hummocks in a coastal forest at Paaste village, Saaremaa Island in 1997. (a) Hummocks of ice moved about 100 m inland within a 0.5 km wide sector of the shore as a result of north-westerly winds resulting in severe damage to a pine forest; (b) The results of the ice assault became evident in summer after the final ice melt: some boulders and sea bottom sediments have been transported to the damaged pine forest

winds and low barometric pressure may raise sea level by nearly 3 m above the Kronstadt zero (benchmark for the eastern Baltic Sea), when major coast changes occur, with cliffs undercut at a higher level, high beach ridges formed, and large quantities of sand moved alongshore. During winter (November to April), a shore ice fringe develops which prevents wave activity, but on spring break up, waves may drive ice onshore, piling it up as 10–15 m high hummocks (Orviku 1965; Orviku *et al.*, 2011). Ice driven onshore scours sea floor sediment, displacing shoreward sand and gravel, and even boulders, damaging trees and buildings (Figure 4.1).

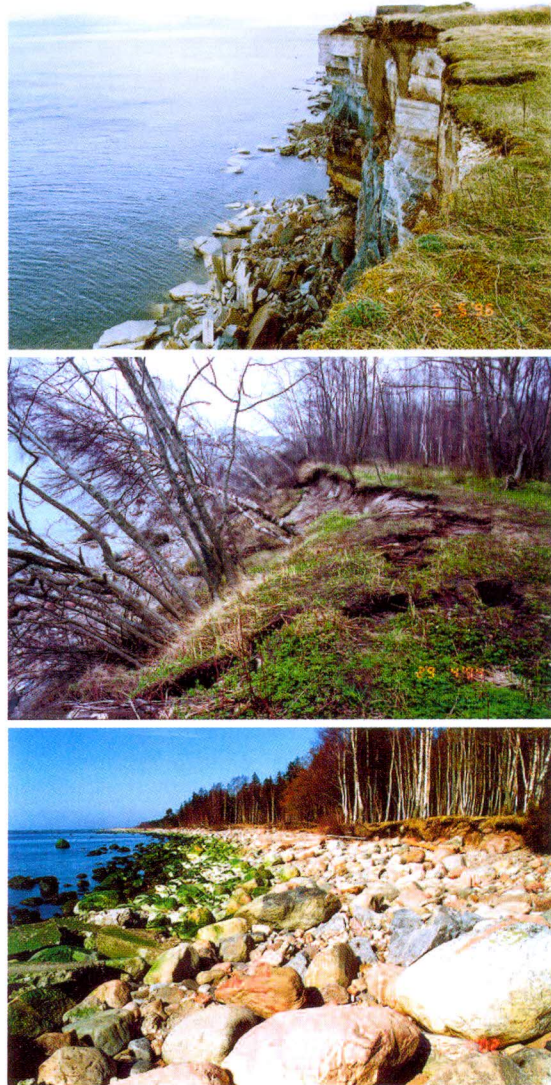
■ **Figure 4.3** Cliff evolution. Top: Pakri cliff, north-western Estonia. Centre: Erosional scarp formed in till in Mõntu, Sõrve Peninsula, Saaremaa Island. Bottom: Finer-grained sediments eroded by waves and remaining boulders, provide a good natural protection against further erosion (Abraded till shore on the western coast of Aegna Island, Tallinn Bay)

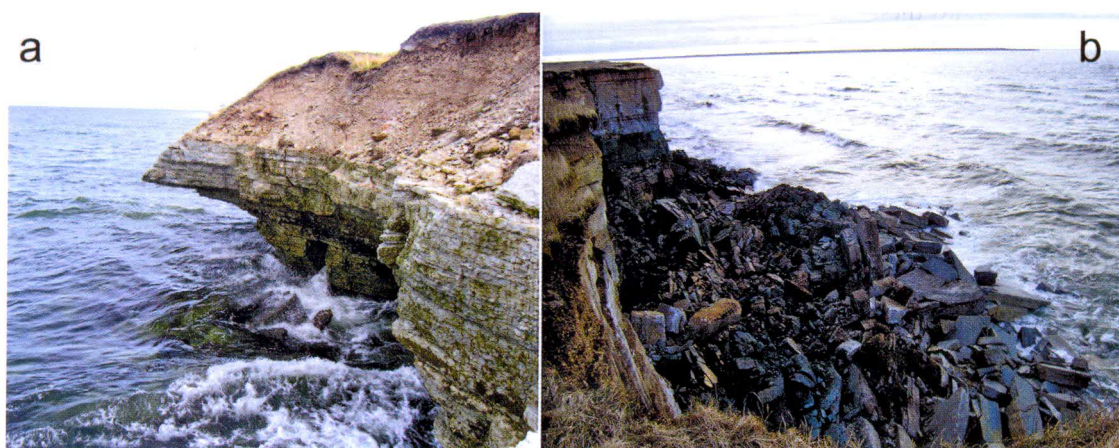
■ **Figure 4.5** (a) The upper part of the limestone cliff is undermined by deep wave-cut notches in non-resistant rocks (e.g. glauconite sandstone), which crop out on the coast of Osmussaar Island; (b) wave-cut notches collapsed and forming a talus slope in front of Pakri cliff

This coast is irregular, consisting of valley-mouth bays with sand beaches and reed beds with limestone headlands and cliffs. Between the capes, wide beaches have formed, backed by dunes and fronted by sand bars. The sand has been derived from Lower Ordovician sandstone in bordering cliffs. On Cape Pakri, a cliff has been cut into relatively soft Lower Ordovician sandstone, overlain by harder limestone. The limestone upper cliff is undermined by wave-cut notches (Figure 4.5a), which causes frequent cliff failure resulting in talus slopes (Figure 4.5b), subsequently reduced by wave activity and eventually gravel beaches.

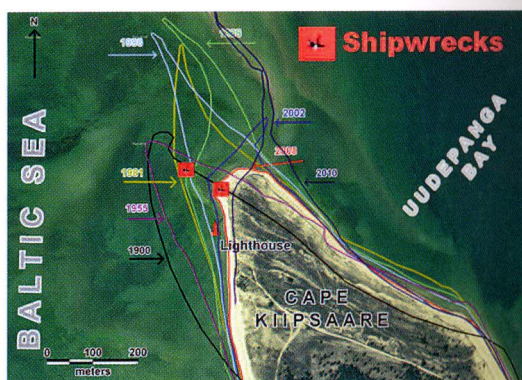
■ **Figure 4.6** Shoreline changes during the period from 1900–2010 (shipwrecks found in 2000 and 2010 are also indicated). Key: black = 1900; Purple = 1955; Yellow = 1981; Green = 1988; Lilac = 1998; Light blue = 2002; Red = 2008; Dark blue = 2010

approximately 150 m from the shoreline and in the middle of the Cape. Estimates of the shore retreat speed between 1933 and 1955 are not possible, but the mean annual velocity of shoreline retreat at Cape Kiipsaare is about 2 m/yr from 1955–1981. More rapid retreat is revealed when comparing aerial photographs from 1981 and 1990 (Figure 4.6). During that decade, the lighthouse ‘shifted’ from a safe distance near the erosion scarp. Shoreline retreat during these ten years was up to 30 m and by 1995, the lighthouse was in the middle of the beach. Even more severe storm damages occurred from 2001–2010, when the shoreline receded approximately 50 m. Today the lighthouse stands over 50 m offshore. Former beach ridges explicitly show the position of earlier shorelines along the western coast. These shorelines are not parallel to the current one, as would be typical of sand beaches, but a 45° intersection of the current shoreline with the axis of former beach ridges is clearly visible in freshly formed scarps – evidence of rapid changes in the direction of shore processes. Additional evidence of the north-eastward migration is given by shipwrecks on the north-eastern coast of the Cape (Figure 4.6), probably wrecked on the north-eastern coast of the Cape 150 years ago. Sand later buried the wrecks, which were re-exposed on the western coast and consequently the Cape has ‘rolled over’ the shipwrecks.

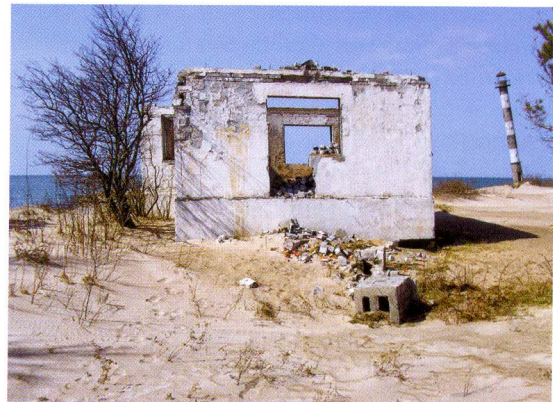
■ **Figure 4.7** The former lighthouse keeper house has been destroyed by various factors, including Soviet army destruction and purely natural processes. Eventually, it will be completely destroyed by coastal erosion

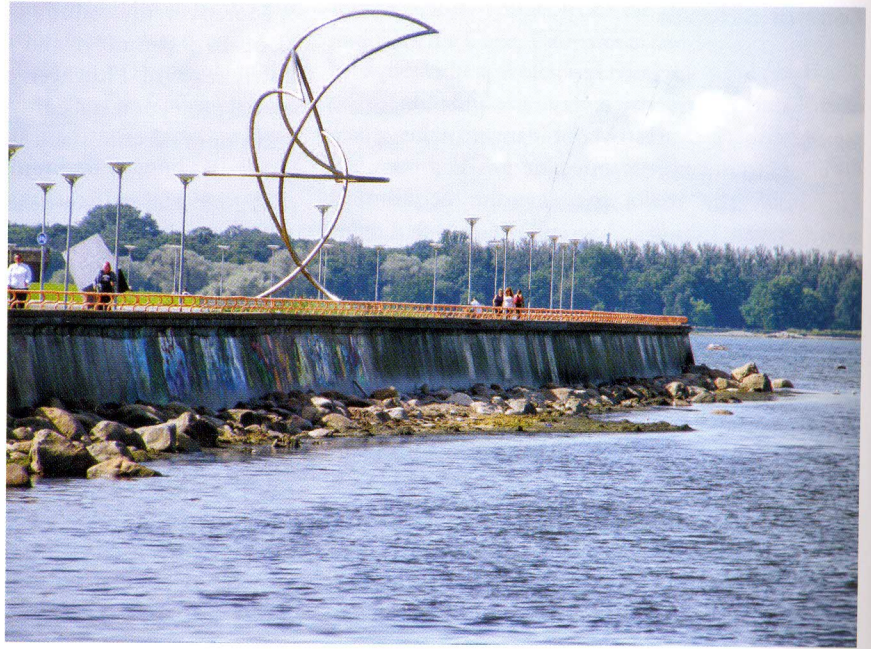
■ **Figure 4.8**
Seawall protecting
Pirita roadway in
Tallin Bay

Very close to the above is Pirita, where a seawall protects the roadway (Figure 4.8) and an artificial sand beach has been created. Pirita River sediments once fed the beach but at present have more or less stopped because of river mouth marina construction. Pirita beach has suffered repeatedly due to extreme storms (1967 and 1975/76). Approximately 30,000 m³ of additional sand was brought from inland sources to nourish the beach for the 1980 Olympic Games (Orviku, 2010). Many more extreme storms have taken place since, including the November 2001 storm and January 2005 storm (Gudrun) which caused extensive erosion. In addition to wave

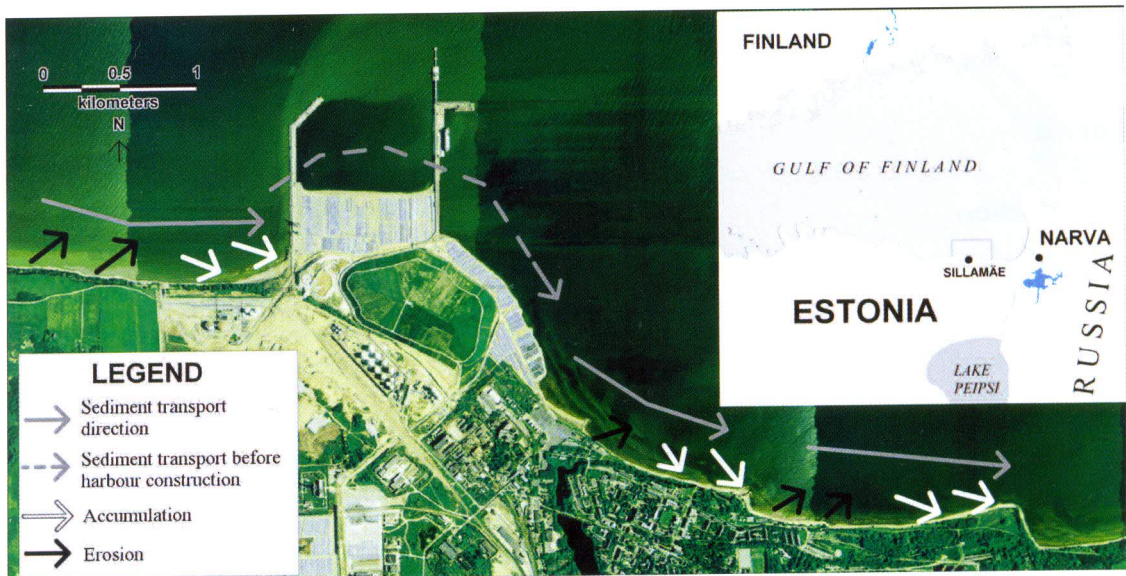
■ **Figure 4.9** Location of Sillamäe and directions of sediment transport (Base image with permission from the Estonian Landboard, compiled by H. Tõnisson)

The last of the coastal protection measure examples in Estonia is the area surrounding a former nuclear waste depository near Sillamäe town, north-east Estonia (Figure 4.9). At the beginning of the twentieth century, boat houses and summer cottages were the most common buildings here (according to a 1934 map), and the shoreline was stable. The first artificial changes appeared when the so-called ‘Swedish harbour’ was established at the end of the 1930s on the eastern side of Cape Päite. The harbour jetty became a sediment trap for gravel-pebble longshore transport from west to east. Sediments trapped behind the jetty accumulated on the northern shore of Cape Päite and the sediment amount in front of Sillamäe (east of the harbour) and the character of shore processes changed. Former accumulation gave way to erosion and the shoreline moved landwards,

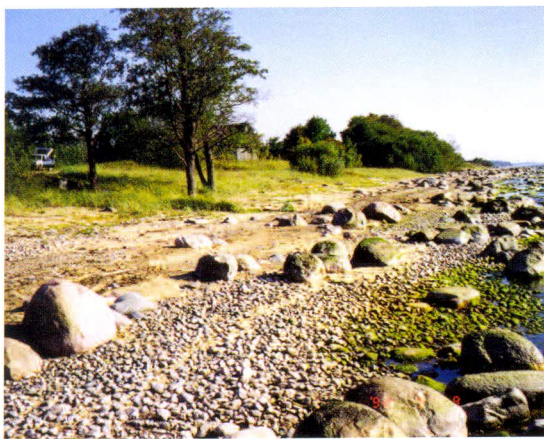
■ **Figure 4.12** *Sediment-deficient slowly retreating coast on the northeastern side of the Gulf of Riga*

Irrespective of the comparatively homogeneous geologic structure, the coastal geomorphology is changing and as a result, areas can be found where continuous accumulation of deposits has occurred on flat shorelines (about 140 km of total length) together with coastal erosion, where cliffs/bluffs (about 150 km in length), with different heights and different geological structures (Figures 4.11, 4.12 and 4.13).

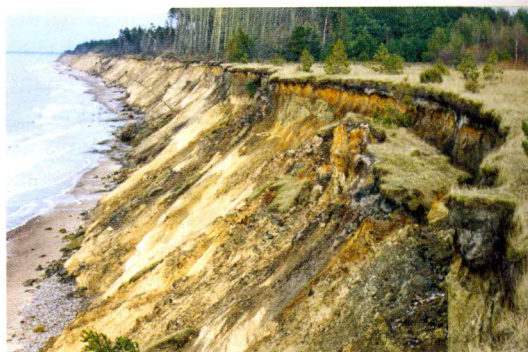
■ **Figure 4.11** *Soft cliff (bluff) in Quaternary deposits on the Baltic coast central section*

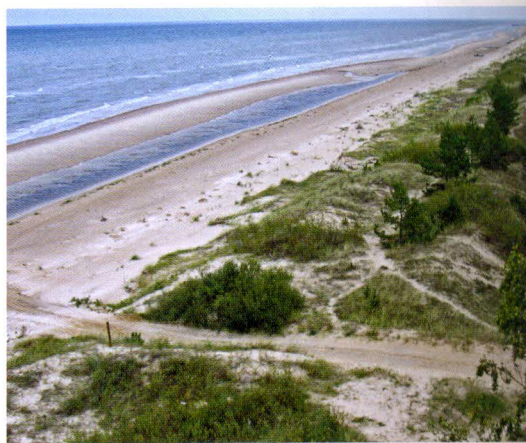
■ **Figure 4.13** *Accumulative coast with sand beach and growing foredunes on the central part of the Irbe Strait coast*

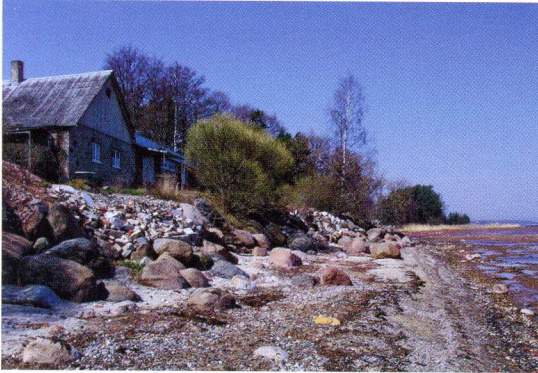
■ **Figure 4.18** Boulder revetment at Valgalciems (western coast of the Gulf of Riga)

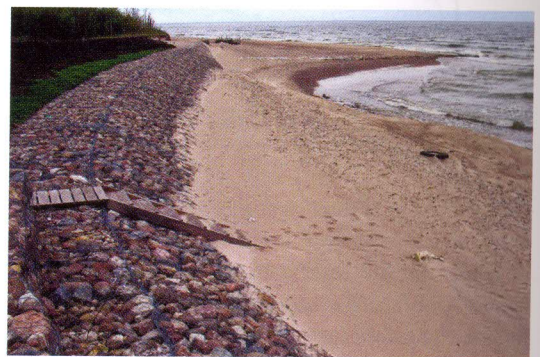
■ **Figure 4.20** Liepāja wastewater treatment plant revetment

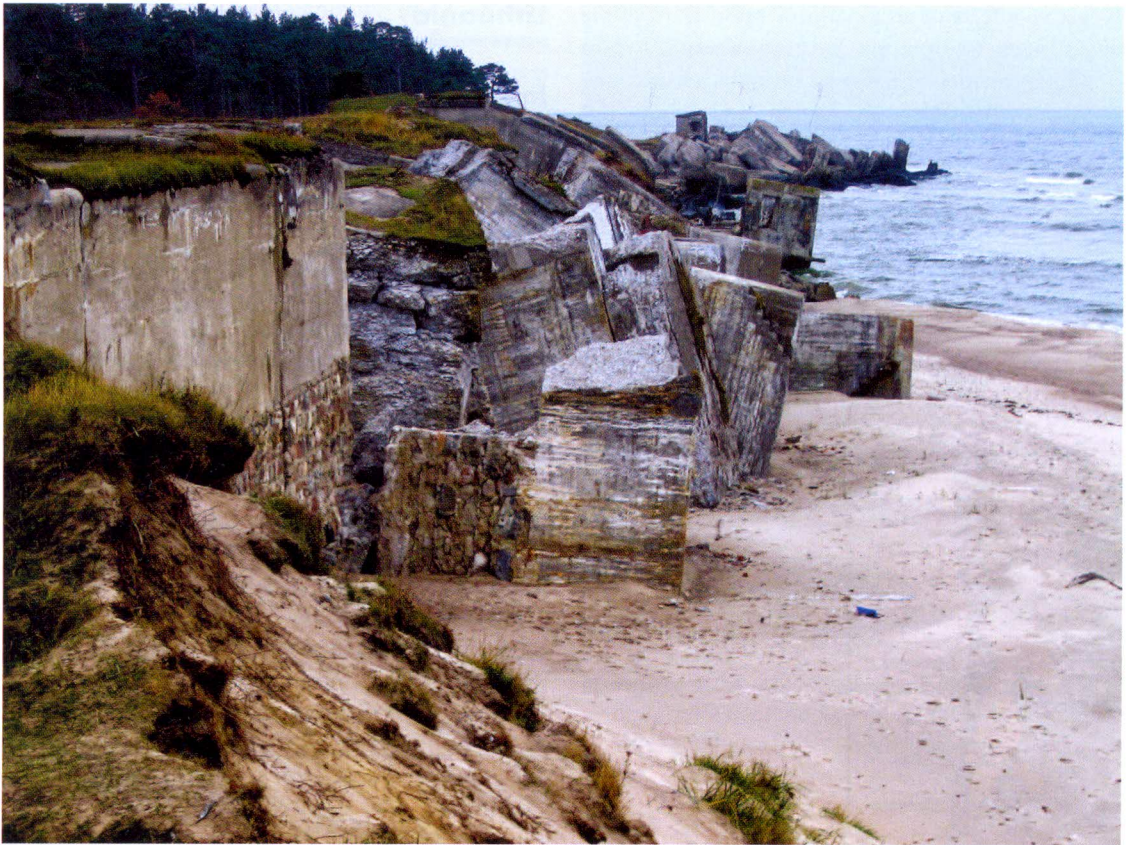
■ **Figure 4.21** *Old military fortification north of Liepāja port*

The massive military fortifications formed in the beginning of the twentieth century and located north of Liepāja port are unique in the context of coastal erosion. Despite being partially destroyed, they continue to function as coastal protection units, maintaining the coastline and further north, cause typical consequences of beach instability and intensification of erosion (Figure 4.21).

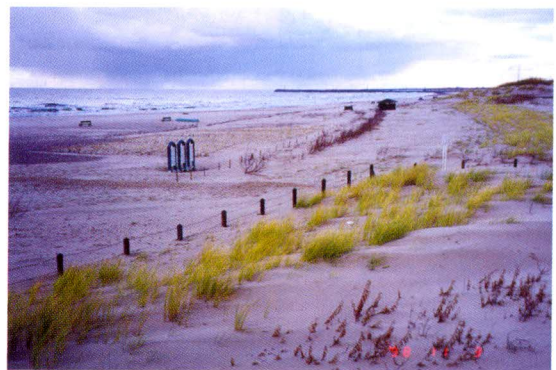
■ **Figure 4.22** *Dune planting close to the southern jetty of the port of Ventspils*

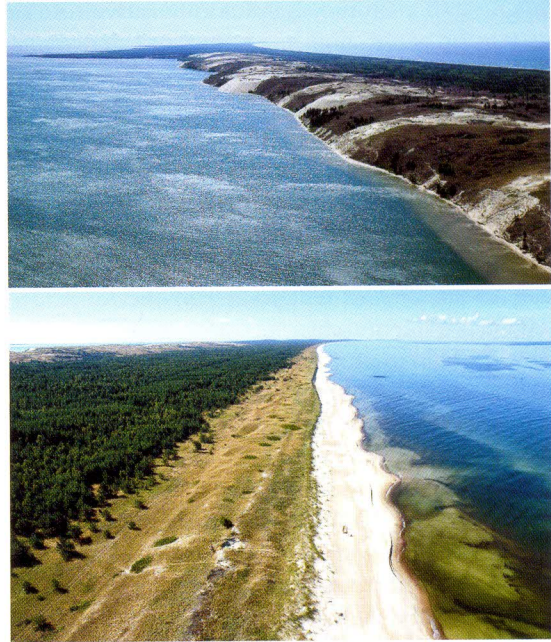
■ **Figure 4.24** Main landscape forms of the Curonian Spit: great dune ridge (top) and foredune (bottom) (Photograph by G. Gražulevičius)

Different relief sections occur along the spit: beach, foredune ridge, blown sand plain, blow-out dune remnants, great dune ridges and the shore of the Curonian Lagoon (Gudelis, 1995). The most dominant element of Curonian spit relief is the ridge of high drifting dunes (Figure 4.24 top), stretching for some 80 km. The ridge width varies from 0.3 to 1 km and average dune height is 30 m, with some reaching 50–60 m. The 31 km long ridge of 40–60 m

Another important element is the foredune ridge, a man-made protective beach dune, whose construction started 200 years ago. It stretches along the entire spit length (Figure 4.24 bottom) with heights varying from 7–8 m at Juodkrantė to 15 m at Koptgalis (in the northern spit) the width ranging from 50–60 m to 90–100 m. The presence of ravines and pits on the foredune top provides evidence of intensive blowout processes. Behind the protective foredune is a vegetated, blown sand plain. The Curonian Spit nearshore is characterized by very specific underwater topography and the presence of two or more 4–6 m high sandbars in water depths of up to 8–9 m (Figure 4.25; Gelumbauskaitė, 2003).

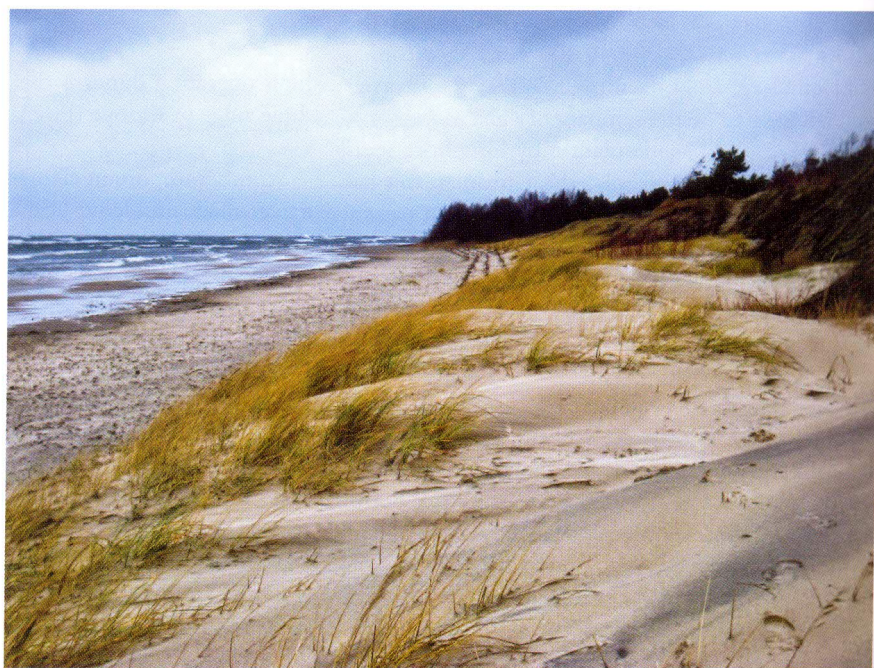
■ **Figure 4.25**
*Beach dunes
between Palanga
and Šventoji*

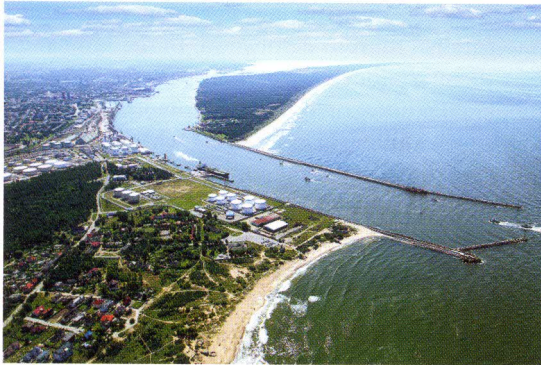
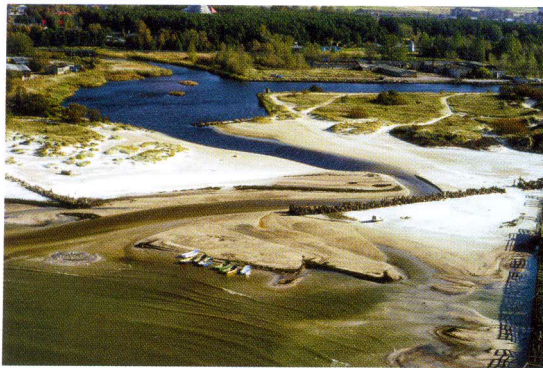
■ **Figure 4.26** Hydrotechnical constructions on shore: Klaipėda sea port breakwaters (top); Palanga promenade pier (centre); old Šventoji port filled with sand (bottom) (Photographs by V. Karaciejus, Klaipėda State Sea Port Authority and A. Tirlikas, PC ORLEN Lietuva)

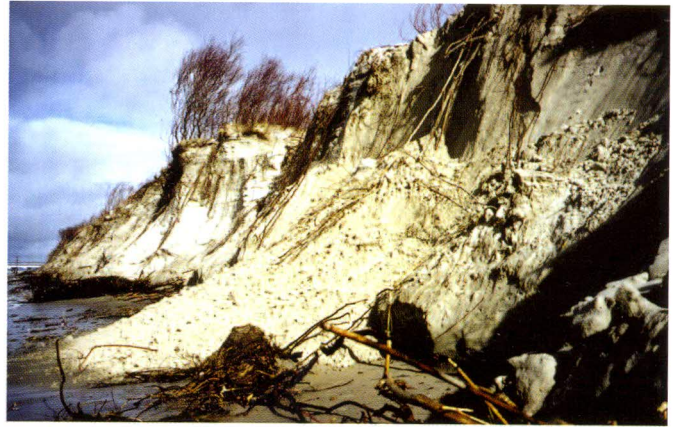
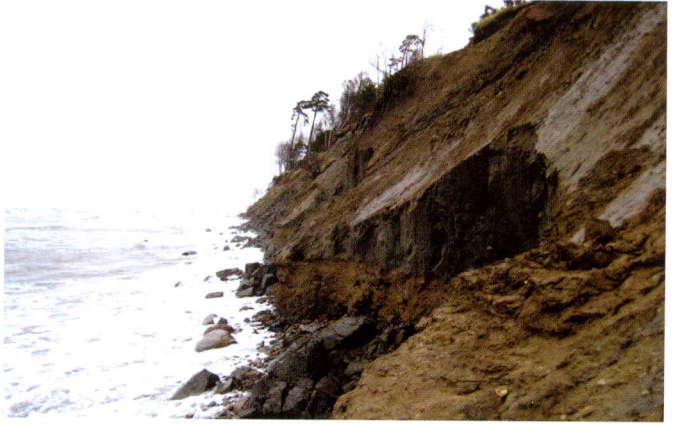
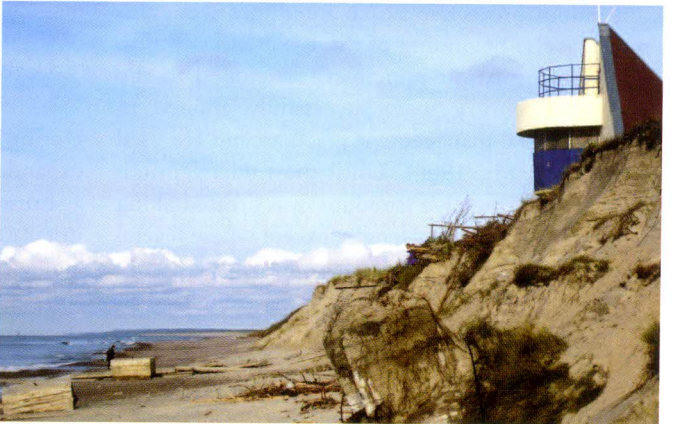
■ **Figure 4.27** Shore dynamics and eroded beach segments

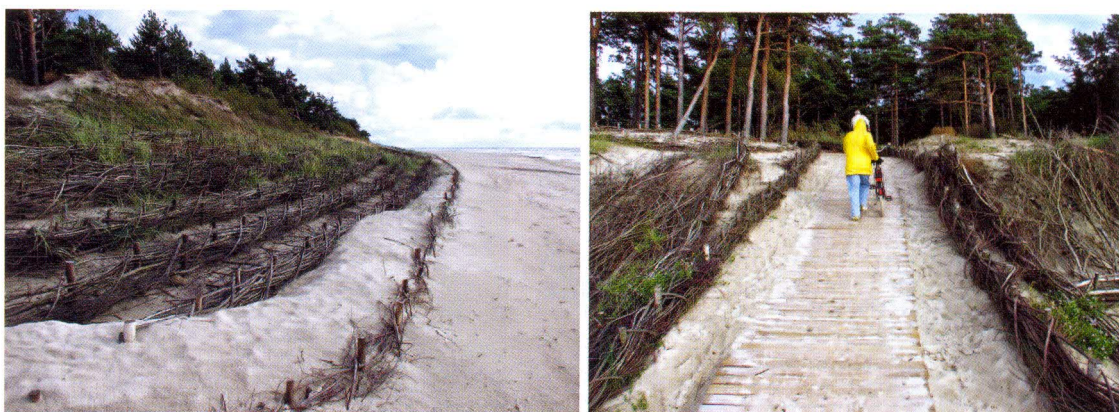
■ **Figure 4.28** *Foredune maintenance by elementary measures near Palanga*

During recent years, coastal protection works have expanded. The protective fore-dune is maintained by a brushwood flooring of fore-dune slopes and installation of brushwood fences, which help catch and accumulate sand, which builds up faster when surface roughness is increased and wicker fences at the dune base facilitate this process. Other measures include construction of wooden stairs and footpaths in recreational areas, planting of greenery in dunes, as well as maintaining natural processes (Figure 4.28).

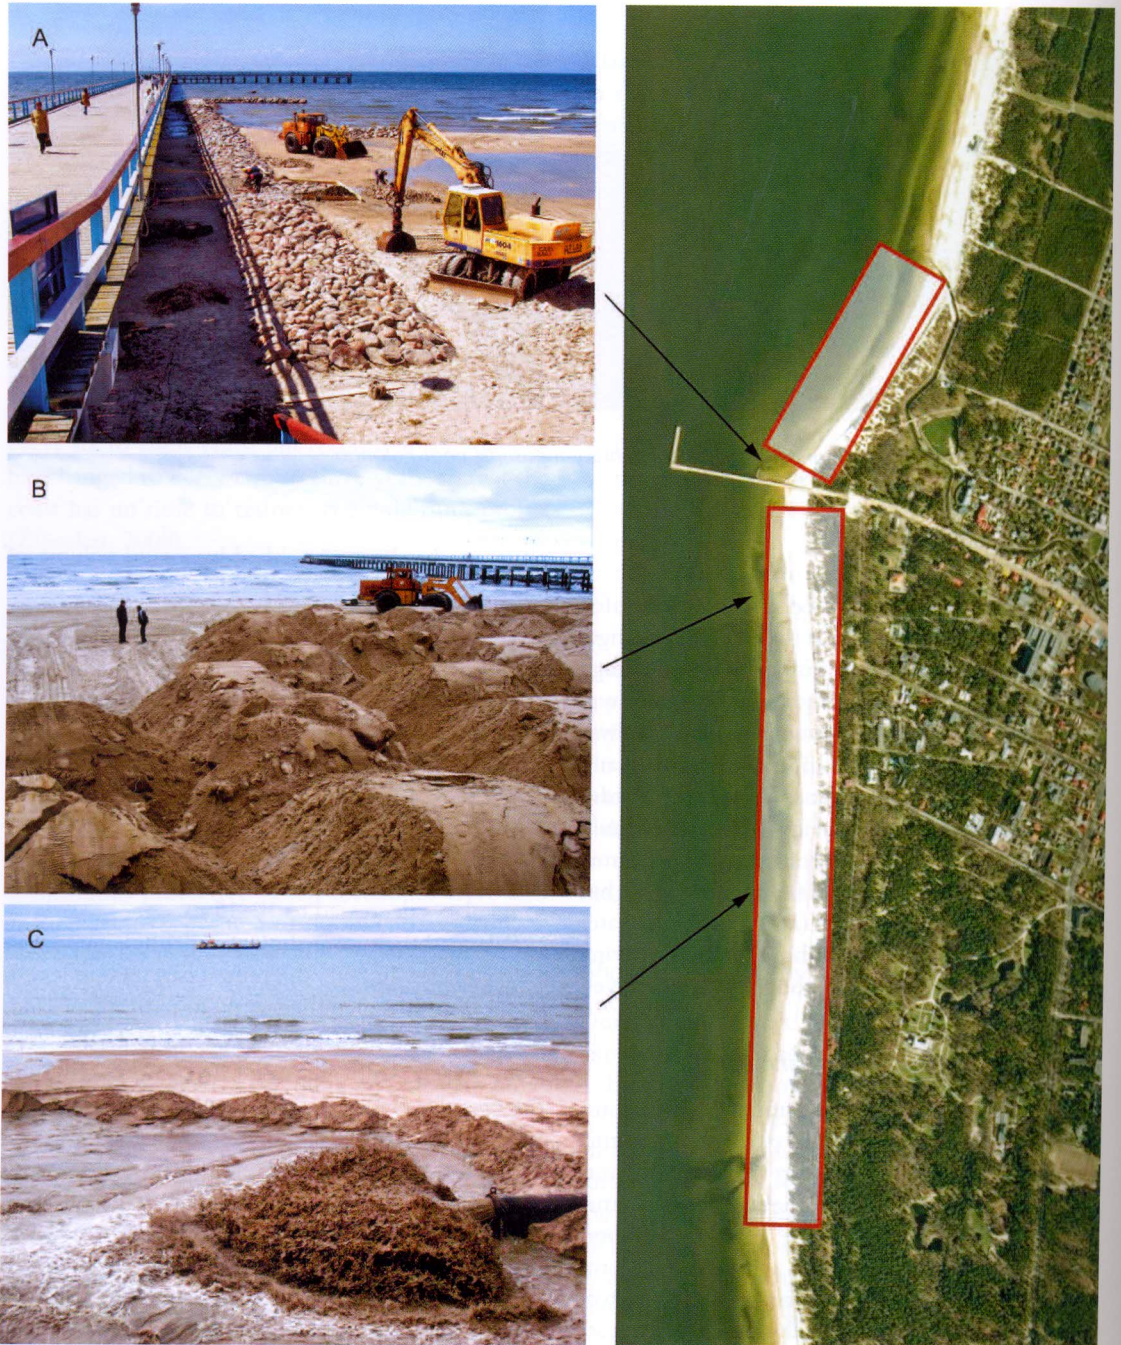
■ **Figure 4.29** Palanga beach regeneration area (right): building of groin (a); beach nourishment (b, c)

Palanga beach nourishment was implemented in several stages. In 2006 the central part (800 m length segment) was replenished with $40 \times 10^3 \text{ m}^3$ of sand, brought from an inland quarry (Figure 4.29b). As a result beach width increased up to 40 m. In 2008 the beach (1,200 m length segment) was nourished with $\sim 111 \times 10^3 \text{ m}^3$ of sand, brought from the seabed (Figure 4.29c). This time the coastal sector width increased by up to 70 m. The third stage of beach nourishment was supplemented in 2011–2012 and the 2.4 km long Palanga beach sector nourished with $424 \times 10^3 \text{ m}^3$ of sand. Monitoring confirmed that beach nourishment had a positive effect on reducing erosion, resulting in an increase in beach width, stabilization of the coastline and nearshore sand accumulation.
